Control Valve Performance Monitoring and Diagnostics

Incorporating a smart digital valve controller can help a control valve monitor its performance and health, and notify the operator of any performance degradation. By Dr. Kung Hun Koy and Ivan Poon.

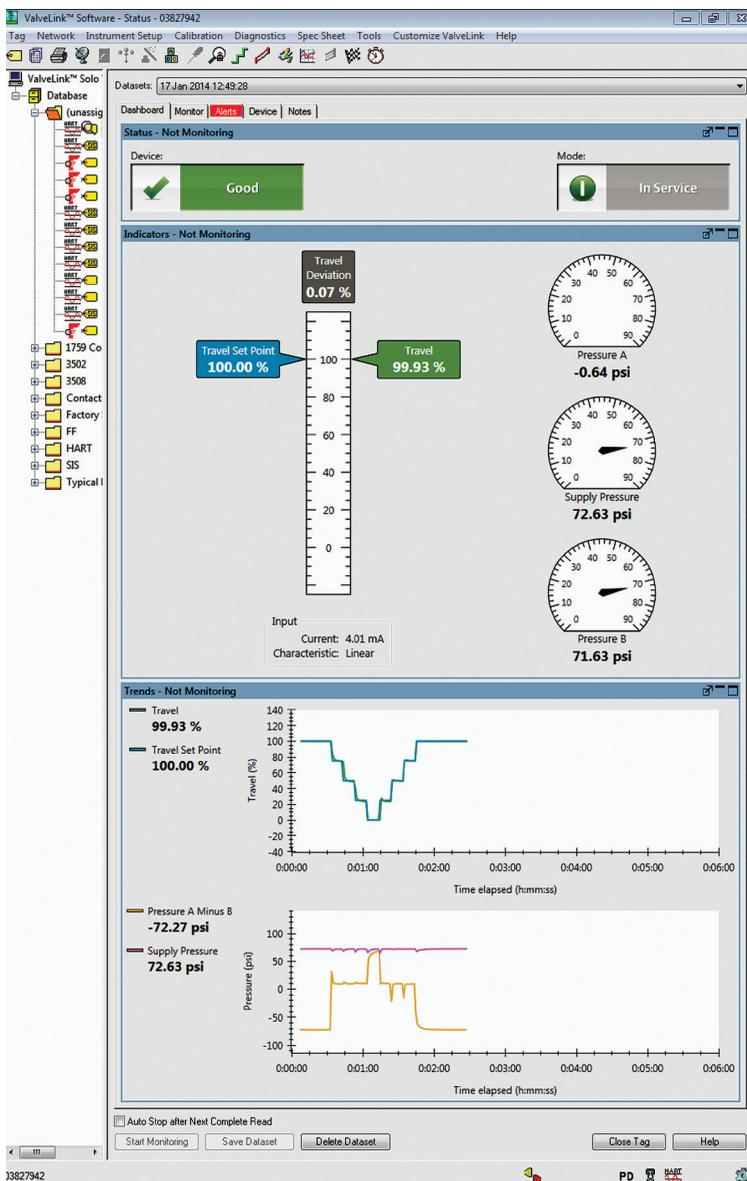
Figure 1. Overview of valve performance with ValveLink software.

With the microprocessor based FIELDVUE digital valve controller (DVC6200 series), there are abundant diagnostics for determining control valve performance. The Dashboard in ValveLink software (Figure 1) provides a quick overview of the valve performance and any performance degradation (e.g. travel deviation or low of supply pressure) is immediately detected and highlighted.

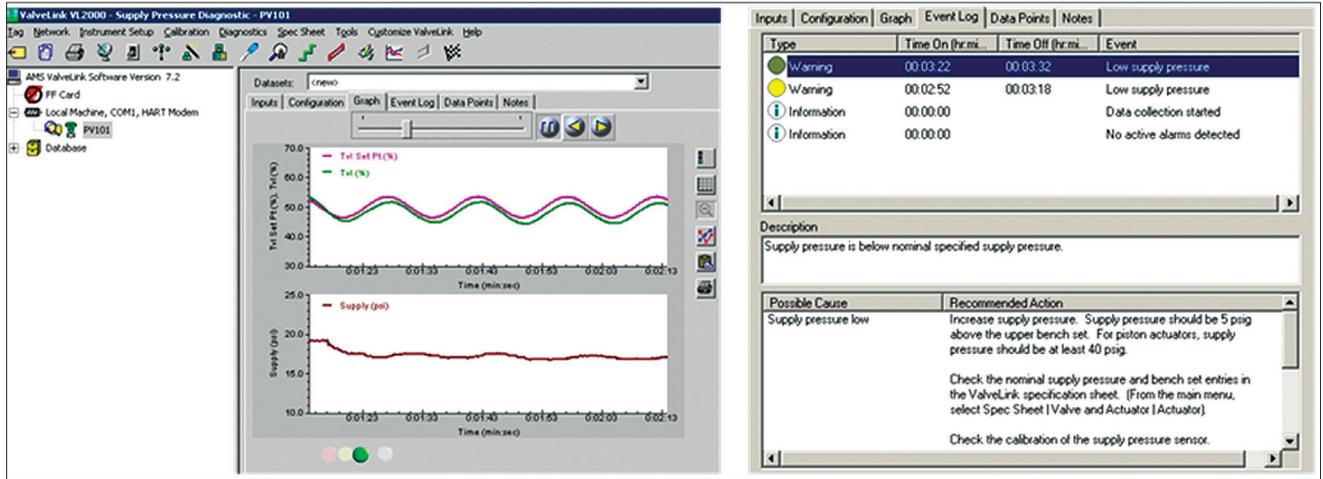
Figure 2. Online supply pressure diagnostics – when low pressure is detected, ValveLink provides the cause of the alert and the recommendations.

Performance Diagnostics is the overarching name for a series of valve assembly diagnostic tests that ValveLink software can run while the control valve is online or in-service. Multiple sensors in the digital valve controller monitor the input current from the controller; supply pressure to the device; output pressure to the actuator; valve position; onboard temperature; drive signal; drive current of the internal I/P transducer; and the relay booster position. Using the online data collected above, it can evaluate supply pressure, determine the relay position of the double-acting actuator to ensure both ports of the relay are in the right position, determine the reasons why a valve assembly is deviating from the set point, evaluate the pneumatic paths (I/P and Relay components) for choke, and detect possible leaks in the pneumatic path through actuator diaphragm or piston O-ring. If any fault is detected by diagnostics, a description of the fault is given that includes possible cause/s and recommended corrective action/s as two of the examples shown in Figure 2 and 3.

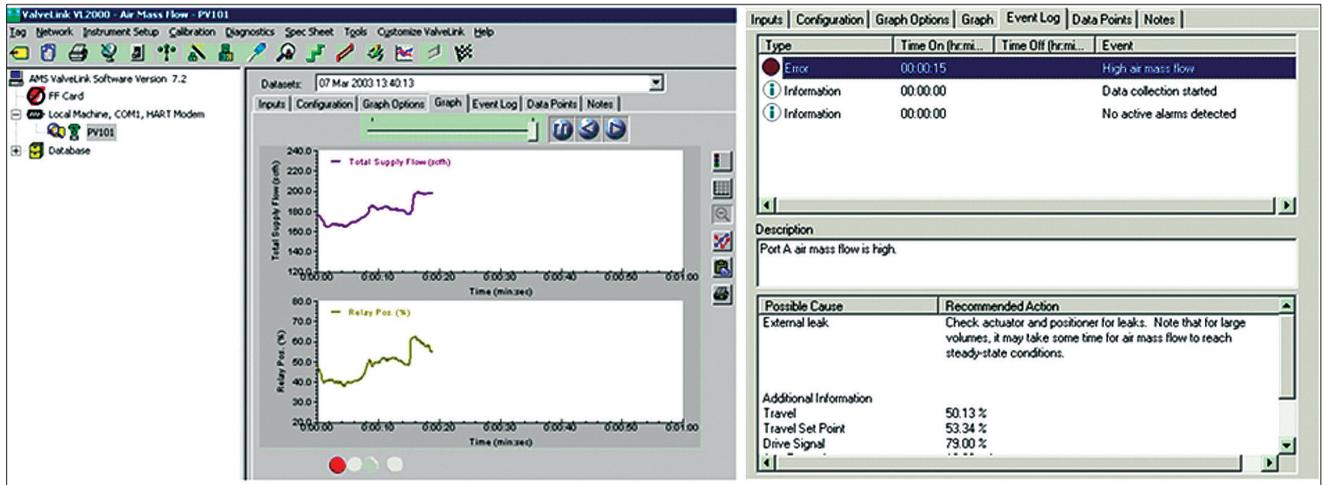
Figure 3. Online air mass flow diagnostics – provide an indication of air leakage when there is external pneumatic leakage.

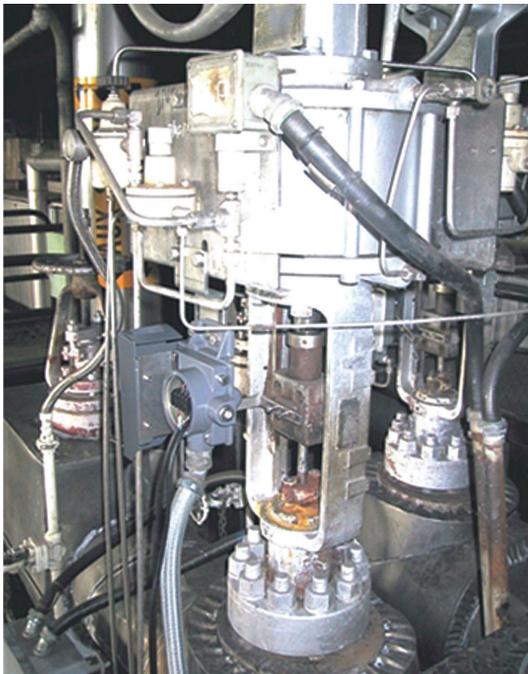
Figure 4. Auxiliary steam control valve with DVC6000 remote mount.

problem traced back to the control valve for that loop. As part of the improvement, the existing positioner was replaced with a Fisher digital valve controller, DVC6000 remote mount (Figure 4). The remote mount positioner was selected in order to prolong the life of the digital valve controller because of the high temperature environment.

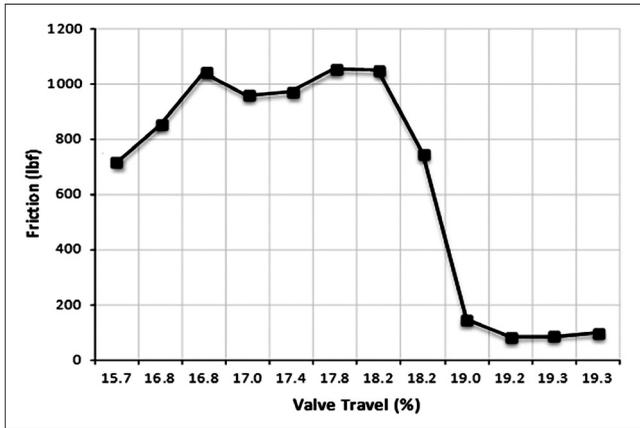
Figure 5. Online friction trend.

Two months into the operation, the operator observed that process variability is still maintaining well when the valve is operating above 19%. However, it is approximately 10 times more when the valve is operating below 19%. The valve will start to slightly oscillate at this low travel range. Online friction testing at various travels was carried out and the result is shown in Figure 5. The graph shows that the friction value is about 10 times higher than normal when the valve openings are between 16 – 19%. With both the offline test and online test put together, we confirm that the packing friction was not the issue. Thus we are able to narrow down to internal parts such as the plug and cage. The valve was scheduled for repair and during the overhaul it was found that four stacks of the noise attenuation trim were badly damaged and choked up (Figure 6). The damaged stacks corresponding to the travel range cause high friction as the valve traverses through these ranges. The valve performance returned to normal after the trim was replaced.

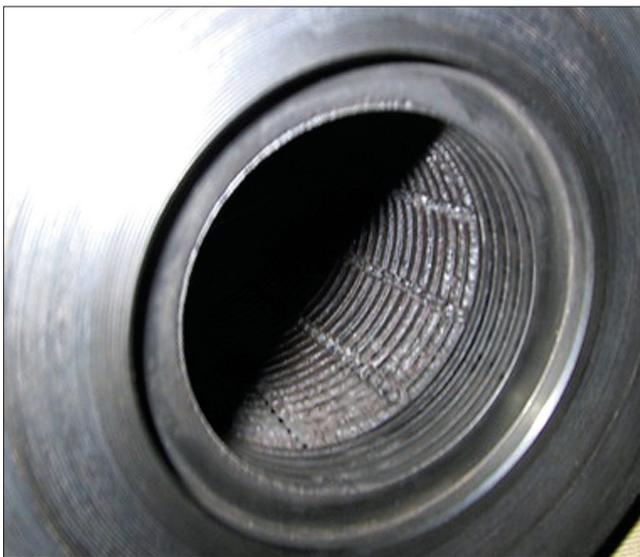
Figure 6. Damaged trim.

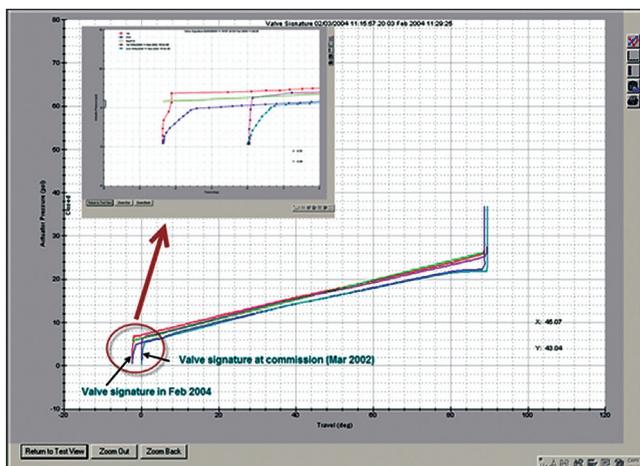
Figure 7. Superimposed valve signature graph at commission and two years after in service.

For example, a chemical plant in Asia will have its valves scanned during shutdown as a routine check even though there is no complaint on their performance during operation. From the valve signature taken, it was found that one of the valves was over-traveling based on the valve signature graph. To ascertain the result, this valve signature was overlaid with the signature that was taken during commission two years ago when the valve was brand new. Figure 7 shows the result of the overlay signatures and the insert is the zoom-in of the seating profiles.

In general the valve signature graphs are almost identical except at the seat end where the latest signature graph shows the valve was over-travelled by approximately 2.4 degrees further than the original signature. In many cases, this is an indication of seat/plug damage. Although the valve performance was not compromised, it was recommended to be scheduled for servicing as the valve might be passing, which could affect the process as well as the plant safety. When the valve was serviced, it was found that the seal protector ring and the HD metal ball seal were damaged (Figure 8), which caused the ball to move further into seating than intended. The seal protector ring and HD metal ball seal were replaced before the valve returned to service.

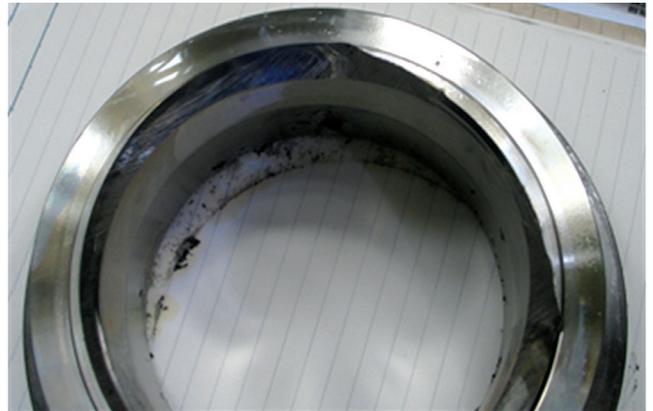
Figure 8. Damaged HD metal ball seal.

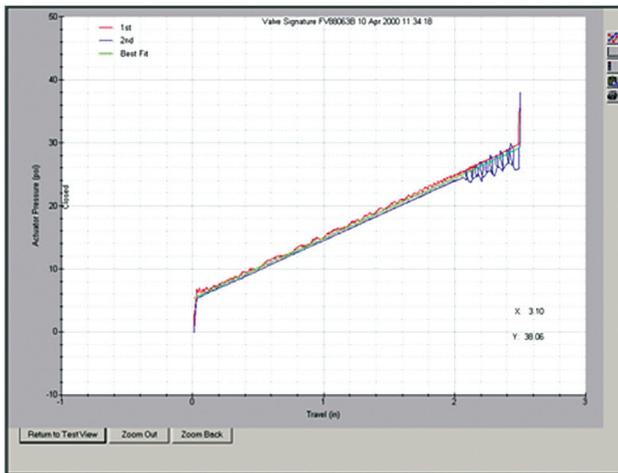
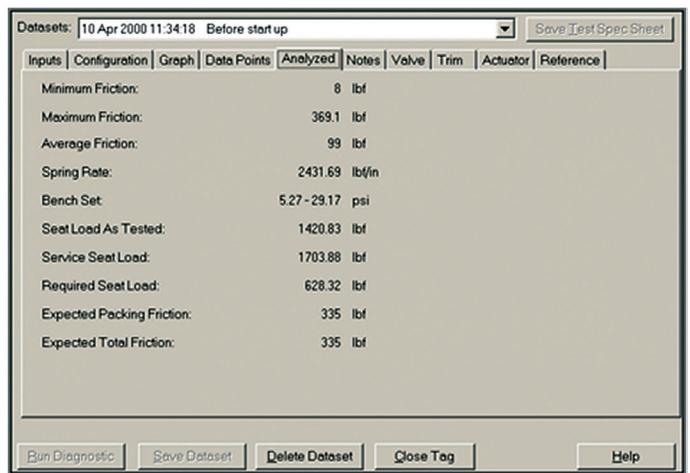
Figure 9. (a) Valve signature graph.

(b) Analysis of valve signature at commissioning.

Detailed analysis of the valve signature graph illustrated in this next example is for a 2" fail closed sliding stem valve, 2.5" travel and a volume booster. Figures 9a and 9b are the respective valve signature graph and its analysis at commissioning. The graph shows a slightly aggressive performance on the return stroke, which is due

to the volume booster. The fluctuation of minimum and maximum frictions is caused by the loopy opening end. The service seat load is well above the required seat load, hence there is sufficient seat load during operation to fully shut the valve according to their ANSI leak class.

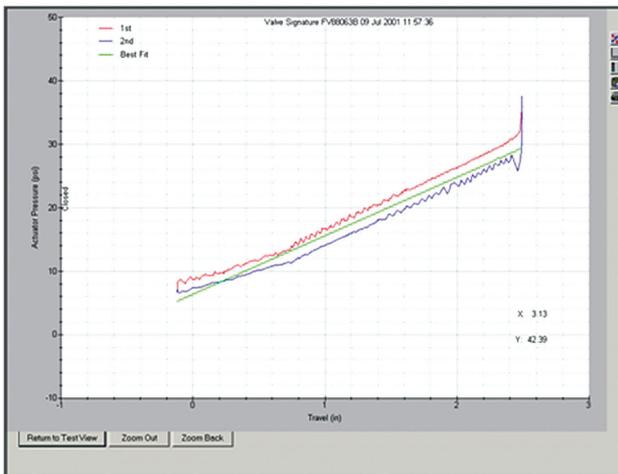
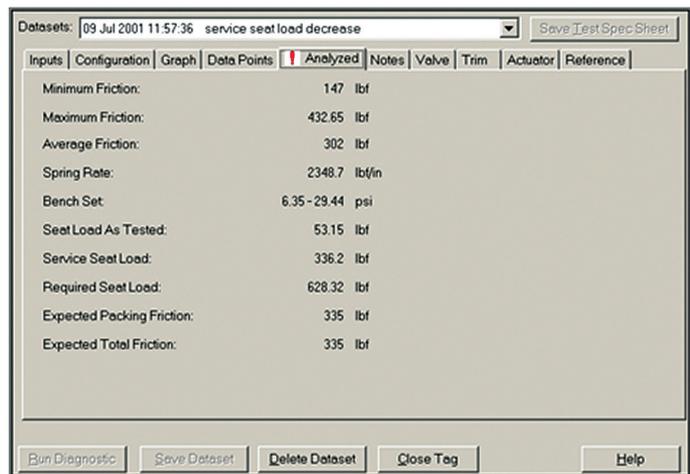
Figure 10. Valve signature and analysis, taken one year after commissioning.

A year after the valve was in operation, there was a complaint of valve passing. A service engineer went on site and ran a valve signature. The valve signature graph and analysis are shown in Figure 10. There are a few observations from the recent valve signature graph.

First, the friction values between 0 – 30% appear to be lower than 30 – 100% of the valve travel range. After the inspection, it was found that the upper part of the stem was severely rusted, because the valve was only operating at up to 30% only. Accordingly, the rusted part of the stem caused an increase in friction.

The second observation was that there was no spike at the seat end, as reflected in the valve signature analysis where the service seat load dropped to almost half the required level. Therefore, the valve was not expected to achieve its shutoff class during normal operation.

The third observation was of the valve over traveling about 0.13” at the seated end. Again, this is an indication of erosion to the seat/plug as in the previous example. Later, the valve was serviced and found that the seat was damaged - the main cause of the seat load reduction.
