EMERSON EXCHANGE 2025

# **A Team Approach to Solving Control Valve Issues & Improved Reliability**

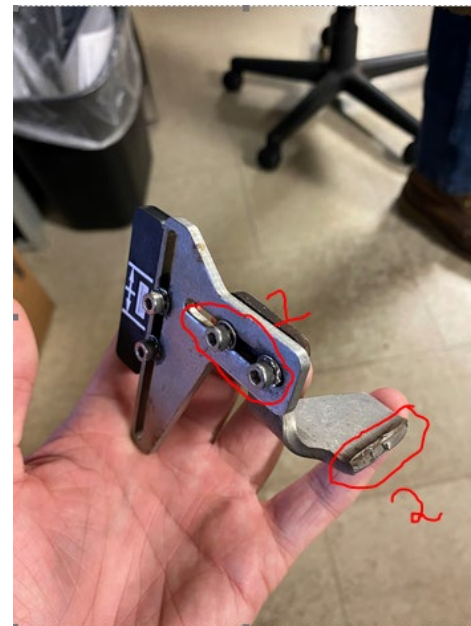
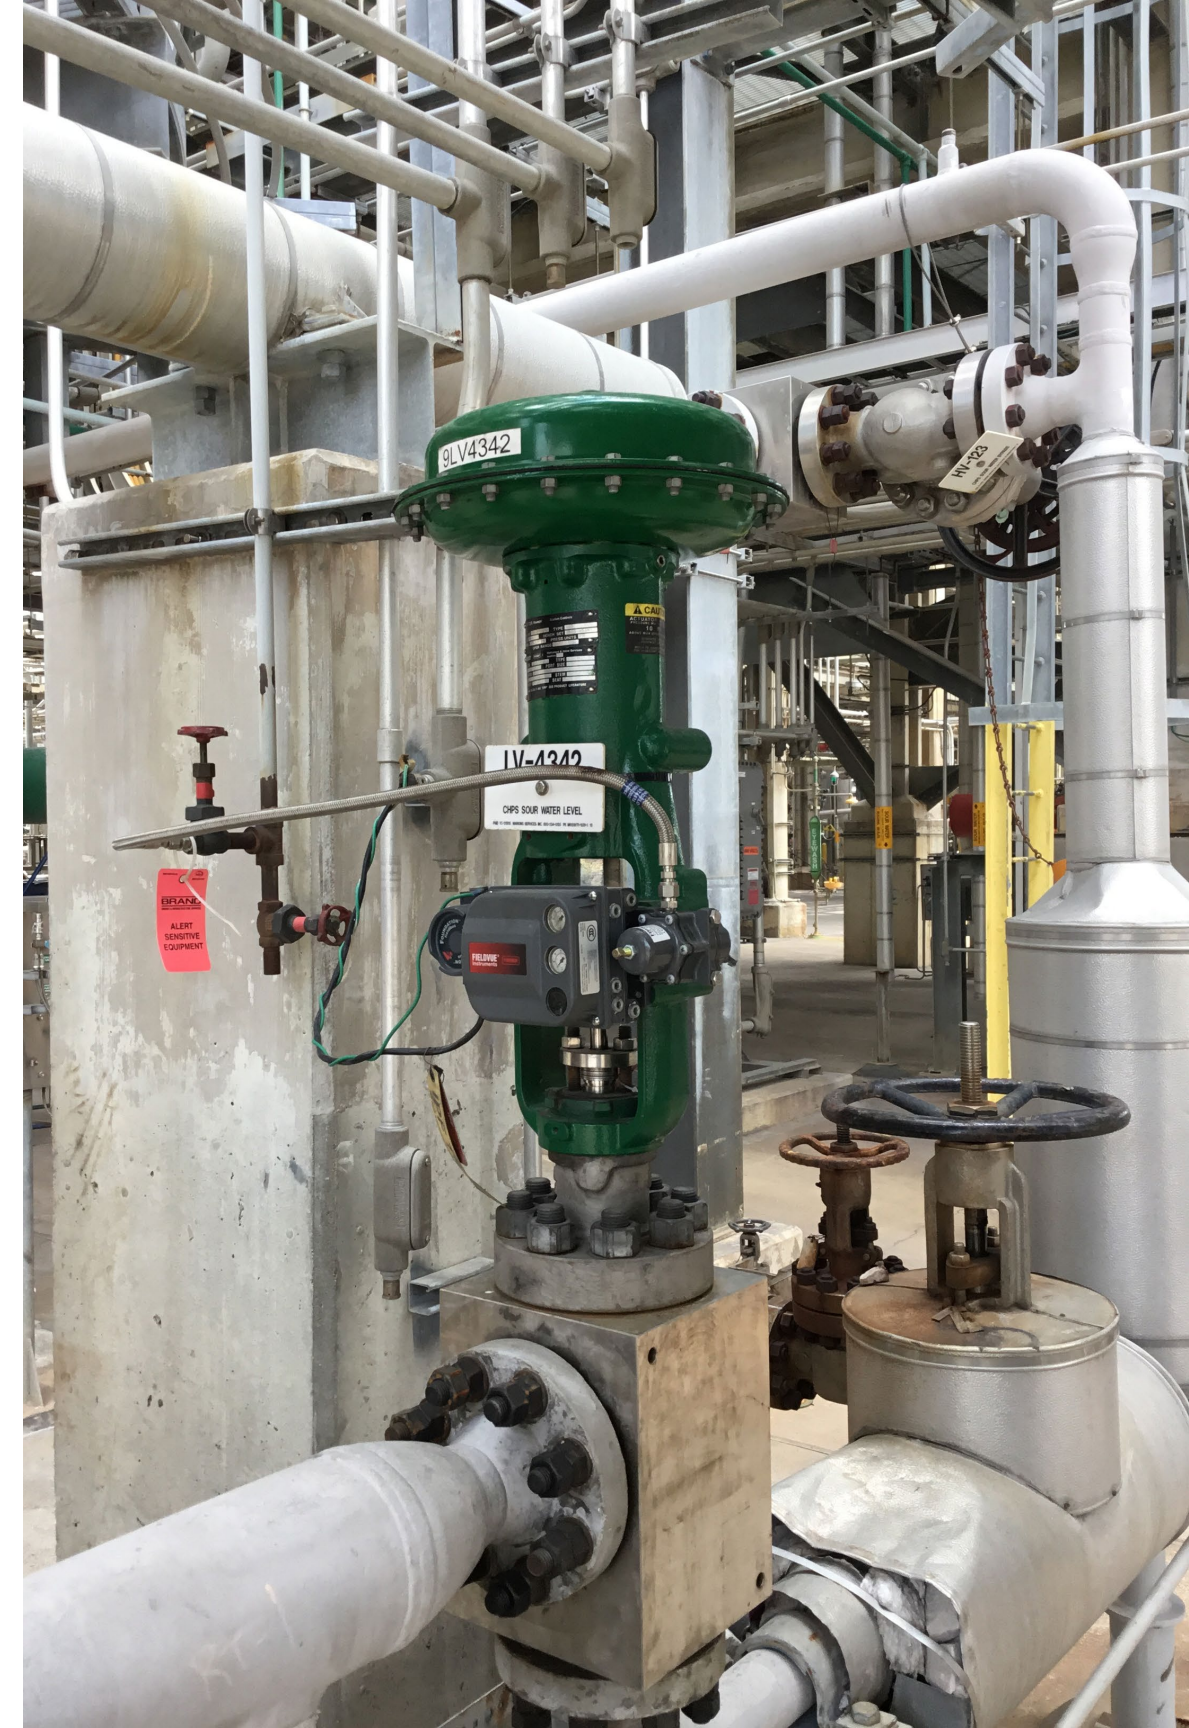
# CFH CHPS Valve

- Existing valve is a 3in Notchflo DST (4-stage)
- Valve had severe high frequency vibration around the stem which resulted in multiple positioner bracket failures bringing the valve to fail position on several occasions.
- Valve experienced several packing leaks due to stem vibration
- During one of the repairs the trim was extremely worn and plug seals were completely missing.

- Due to a debottlenecking project the outgassing outlet volume ratio went from .2 to .8
- The valve position was originally around 40% in 2015 and steadily increased year over year until the debottleneck in 2019 where position jumped to 80-90%.
- The original Notchflo was designed to combat cavitation. Since the outlet volume gas ratio drastically increased we discovered that we needed a valve that could combat the aerodynamic noise issue due to the challenging outgassing scenario.
- We also used Emerson's wireless vibration monitor to build a business case for the replacement.

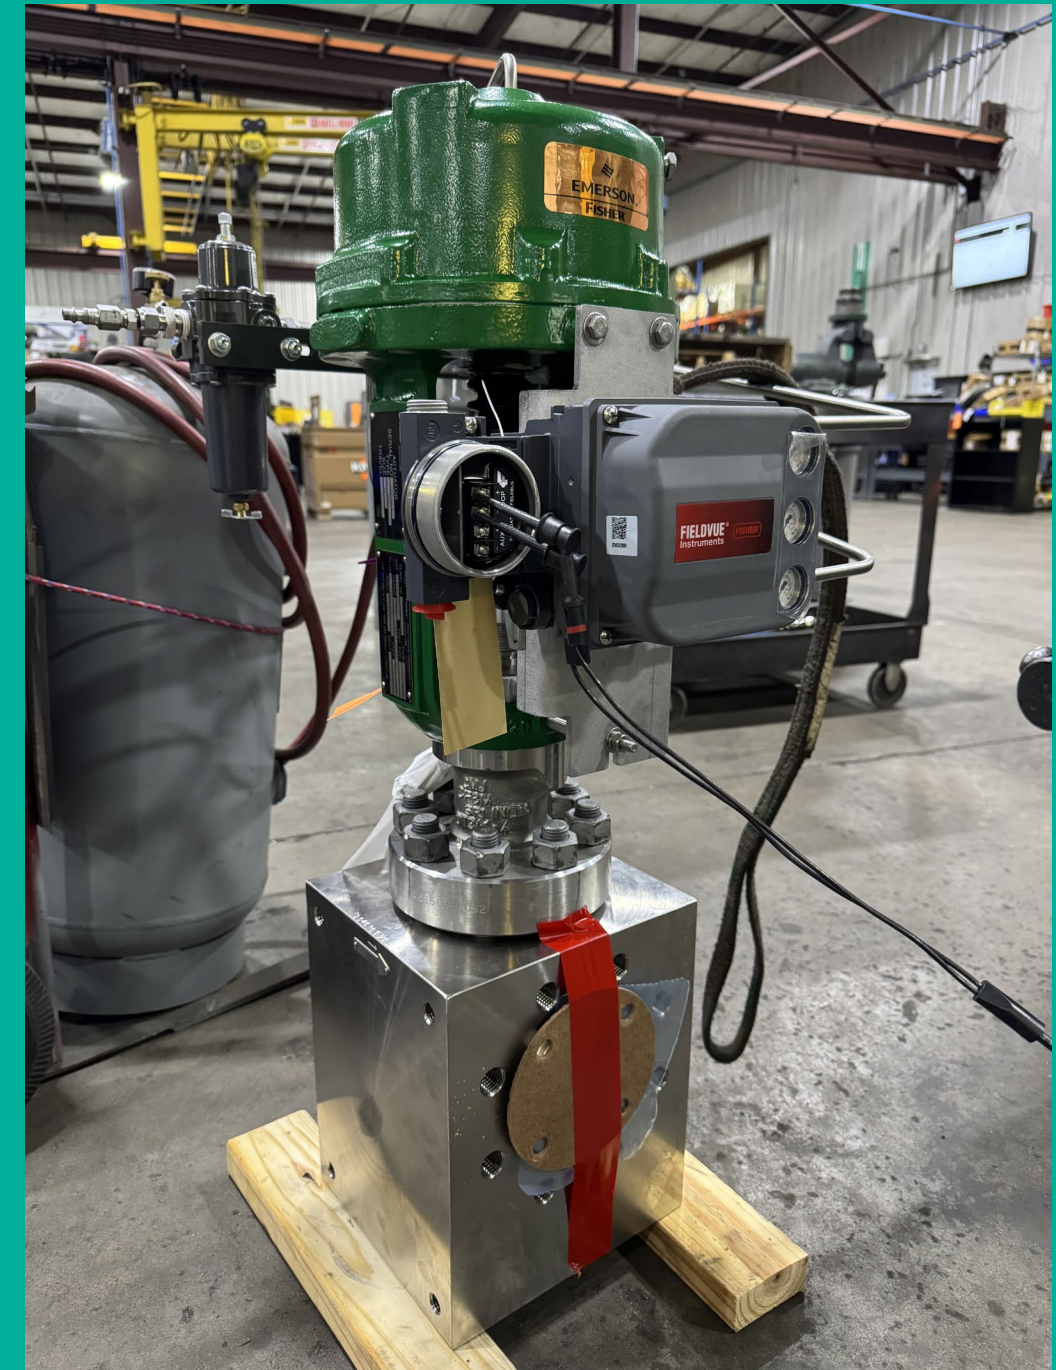
# CFH CHPS Valve

- Current Issue - Increased gas exiting the valve causing higher frequency vibration; aerodynamic noise likely contributing more than cavitation.
- Original Design - Sizing based on cavitation handling, not aerodynamic noise (Notchflo was selected for cavitation).

- Solution - Switch to a Fisher HPAS single-stage whisper A1 solid alloy cage with drilled holes for better noise abatement and reduced stem vibration.

- Trim Update - New trim installed in existing block-forged body to avoid piping modifications.
- Stem/Plug Assembly - Machining a one-piece stem/plug (instead of pinning) for added strength, reduced vibration, and eliminated risk of plug detachment.

- Actuator Sizing - Double-acting piston actuator with volume tank for better plug stability and reduced vibration.
- DVC Mounting - Plan to eventually remote-mount the DVC on a pipe stand to protect from unnecessary vibration.

- Additional Benefit - Going unbalanced eliminates the balanced plug seal and seal ring, removing a potential failure point.

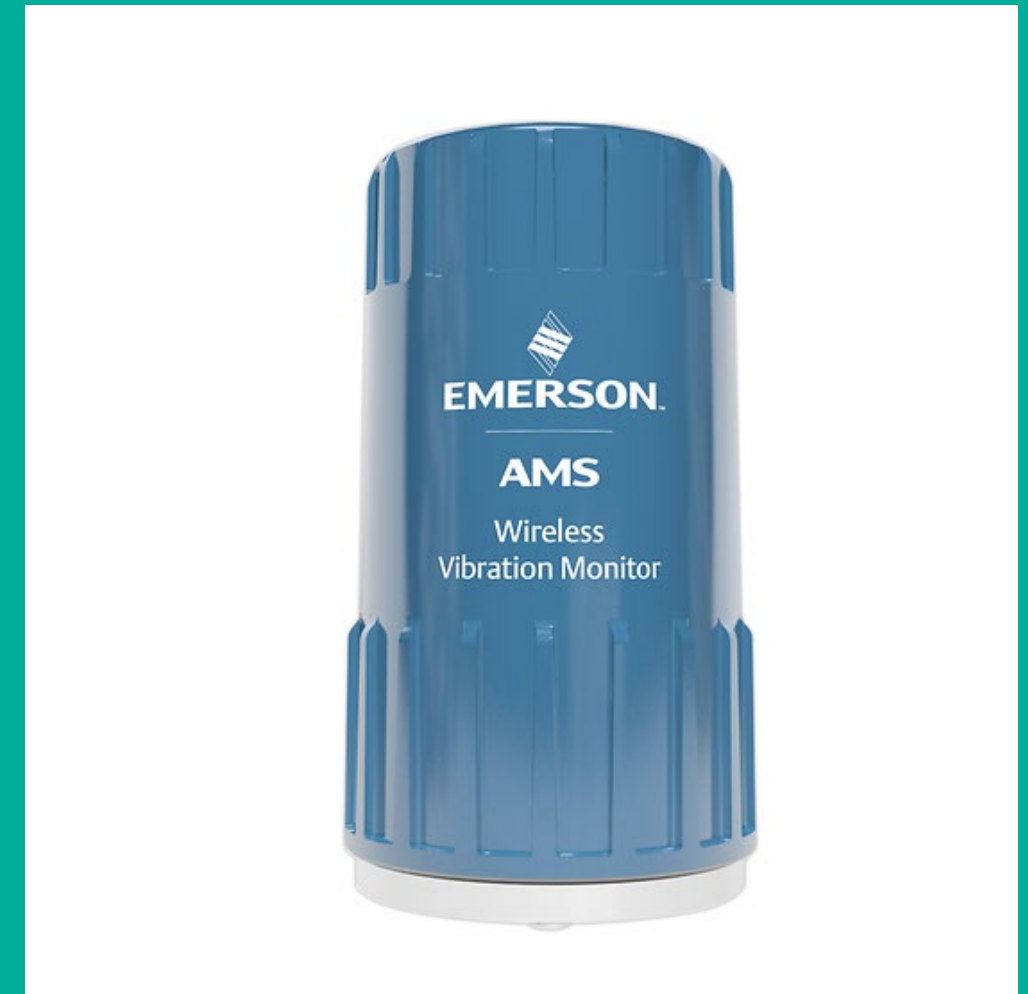
# Extremely Noisy Naphtha Valve

- A 4in Vee ball was sold to replace a 6in E body as a low cost solution
- Based on original conditions, sizing did not show any noise concerns
- Once installed the valve was extremely noisy (some readings as high as 110dB)
- The 4in Vee ball was sized, quoted and replaced under normal maintenance practices with no concerns or red flags until the valve was installed

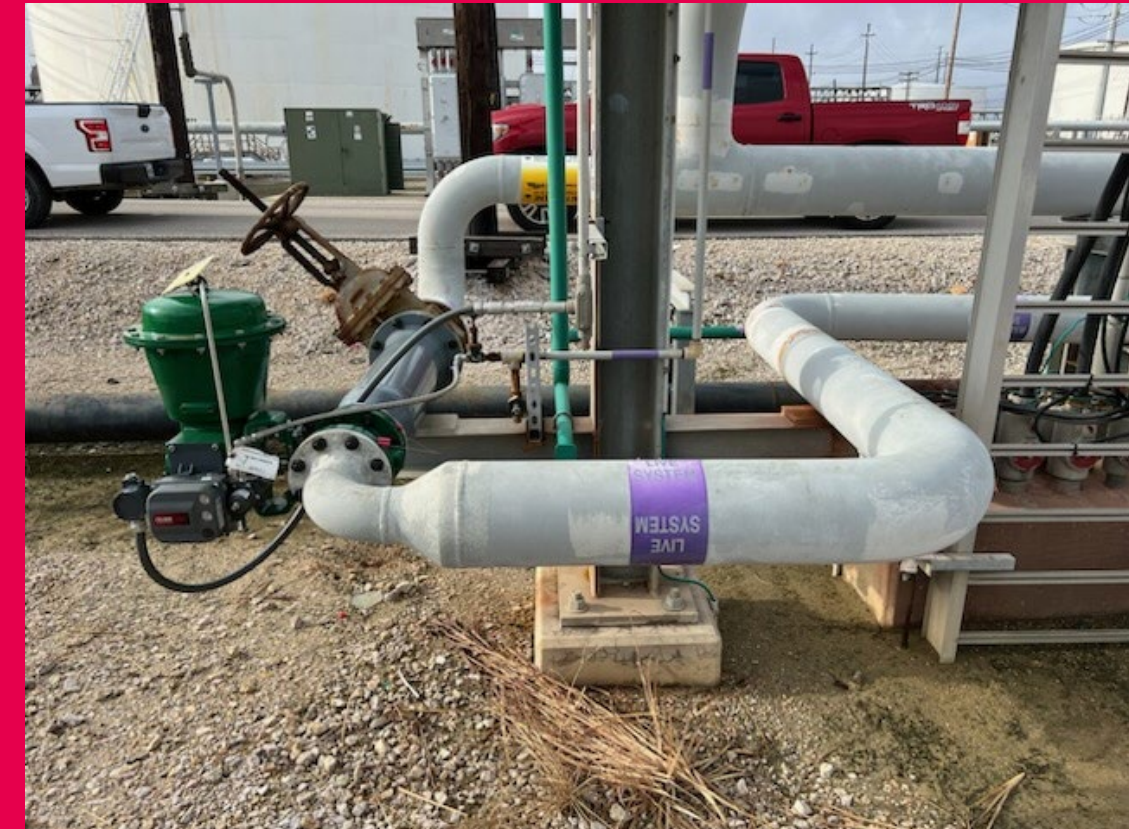
# Extremely Noisy Naphtha Valve

- After the 4in Vee ball was installed and reported to be very noisy, we planned a field walk to evaluate the installation.
- The piping arrangement was far from ideal. Upstream piping was 12in, then 8in and then swaged down to 4in at the valve.
- Immediately downstream of the valve was a pipe elbow and then swaged back up to 8in and then 12in pipe.
- Since this is a blending valve the amount of flow through the valve depends on the amount of Naphtha needed in the blend.
- Due to the piping arrangement and gathering updated process conditions we determined that a larger valve with pressure staging and noise attenuation would be needed.
- We also used Emerson's wireless vibration monitor to build a business case for the replacement.
