Eliminating Control Valve Erosion – a Journey to a Better Mouse Trap

Erosive Severe Service

Thickener Underflow Application

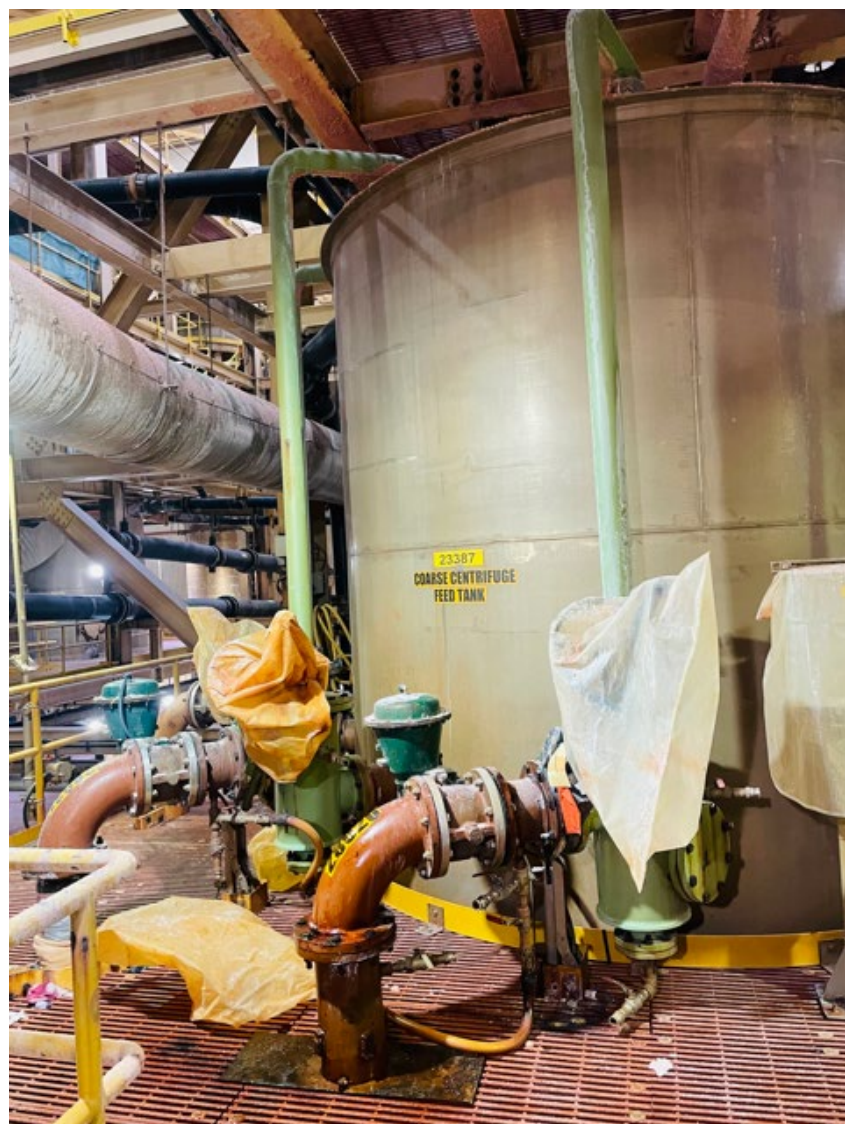
Centrifuge Feed Application

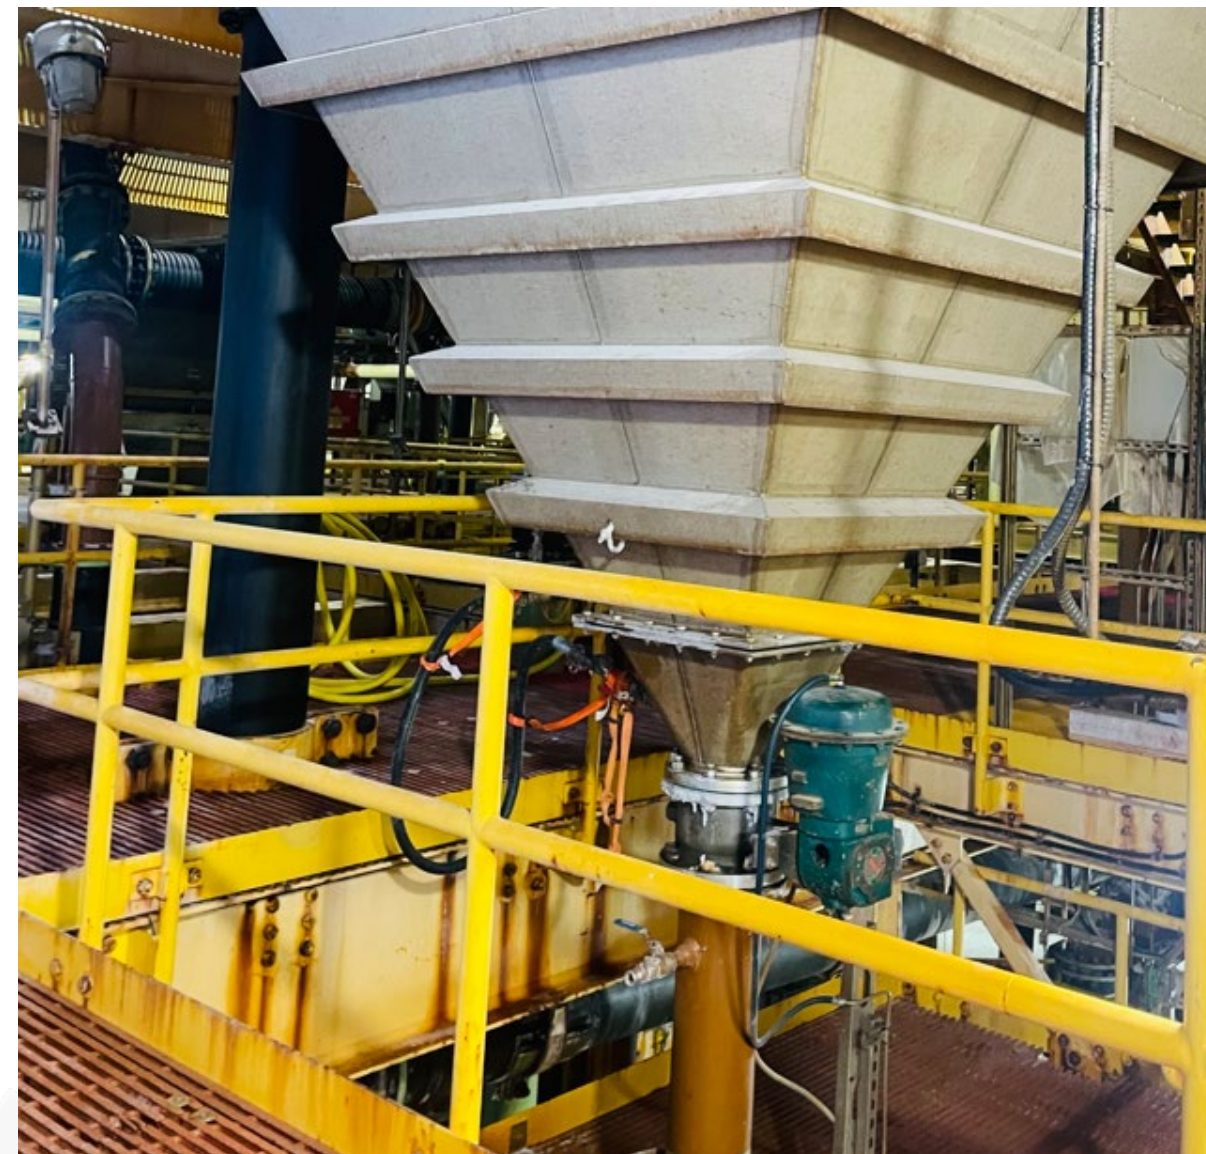
Cross Flow Separator

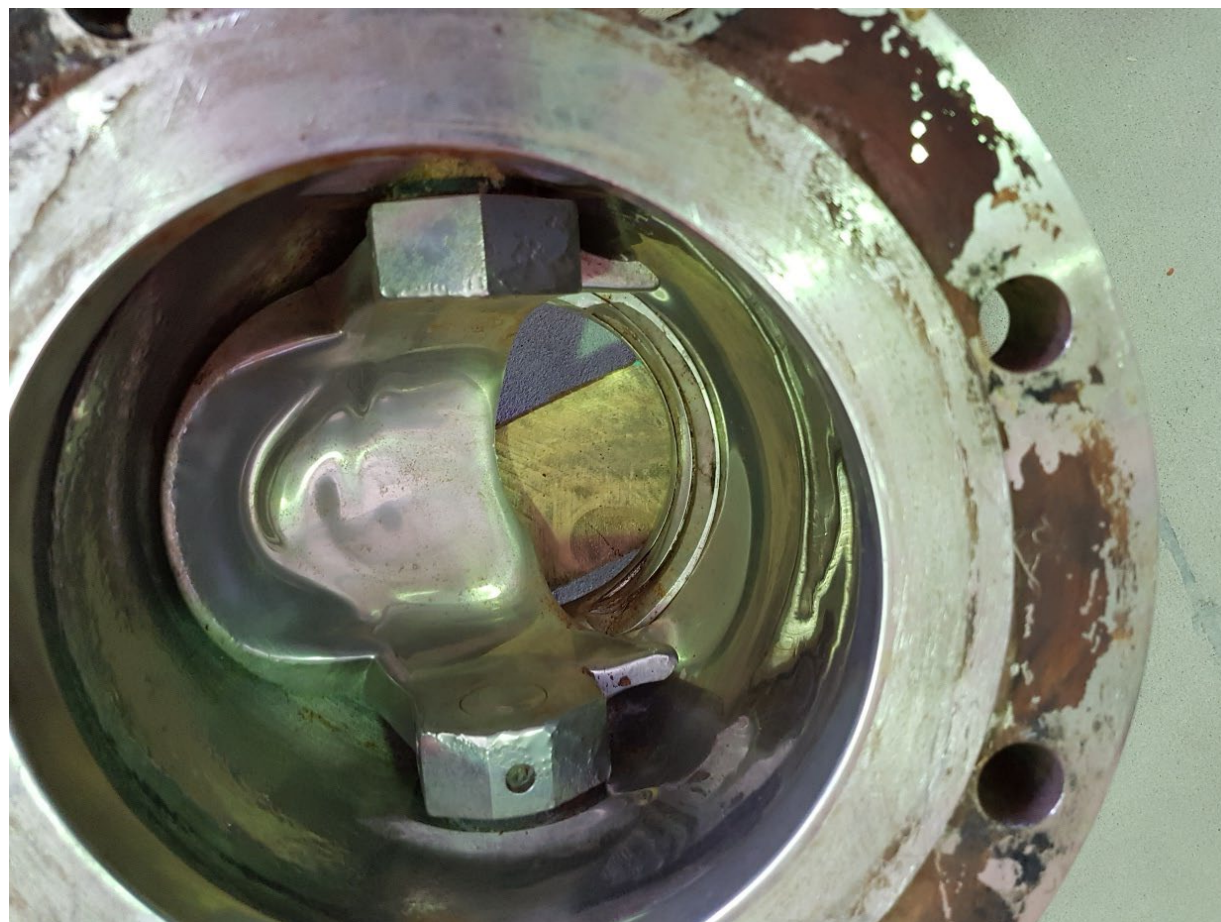
8" V150, SST body, Reverse Flow

- Letters off casting are worn off
- Body has mirror finish
- Eventually led to a hole in the valve body

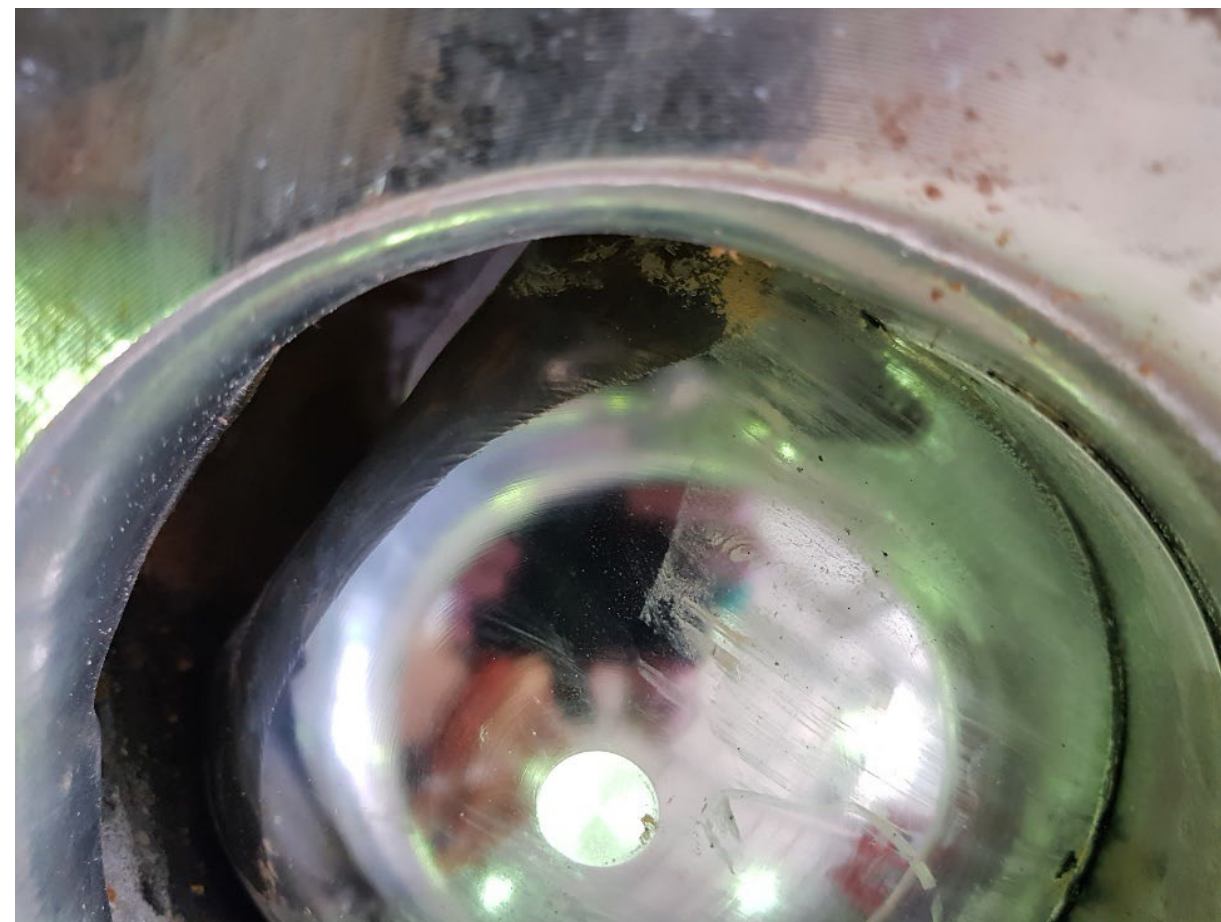
Ball was razor sharp

- Some of the “V” is eroded away
- Seat ring is eroded and partially missing
- Some ball material & coating worn away

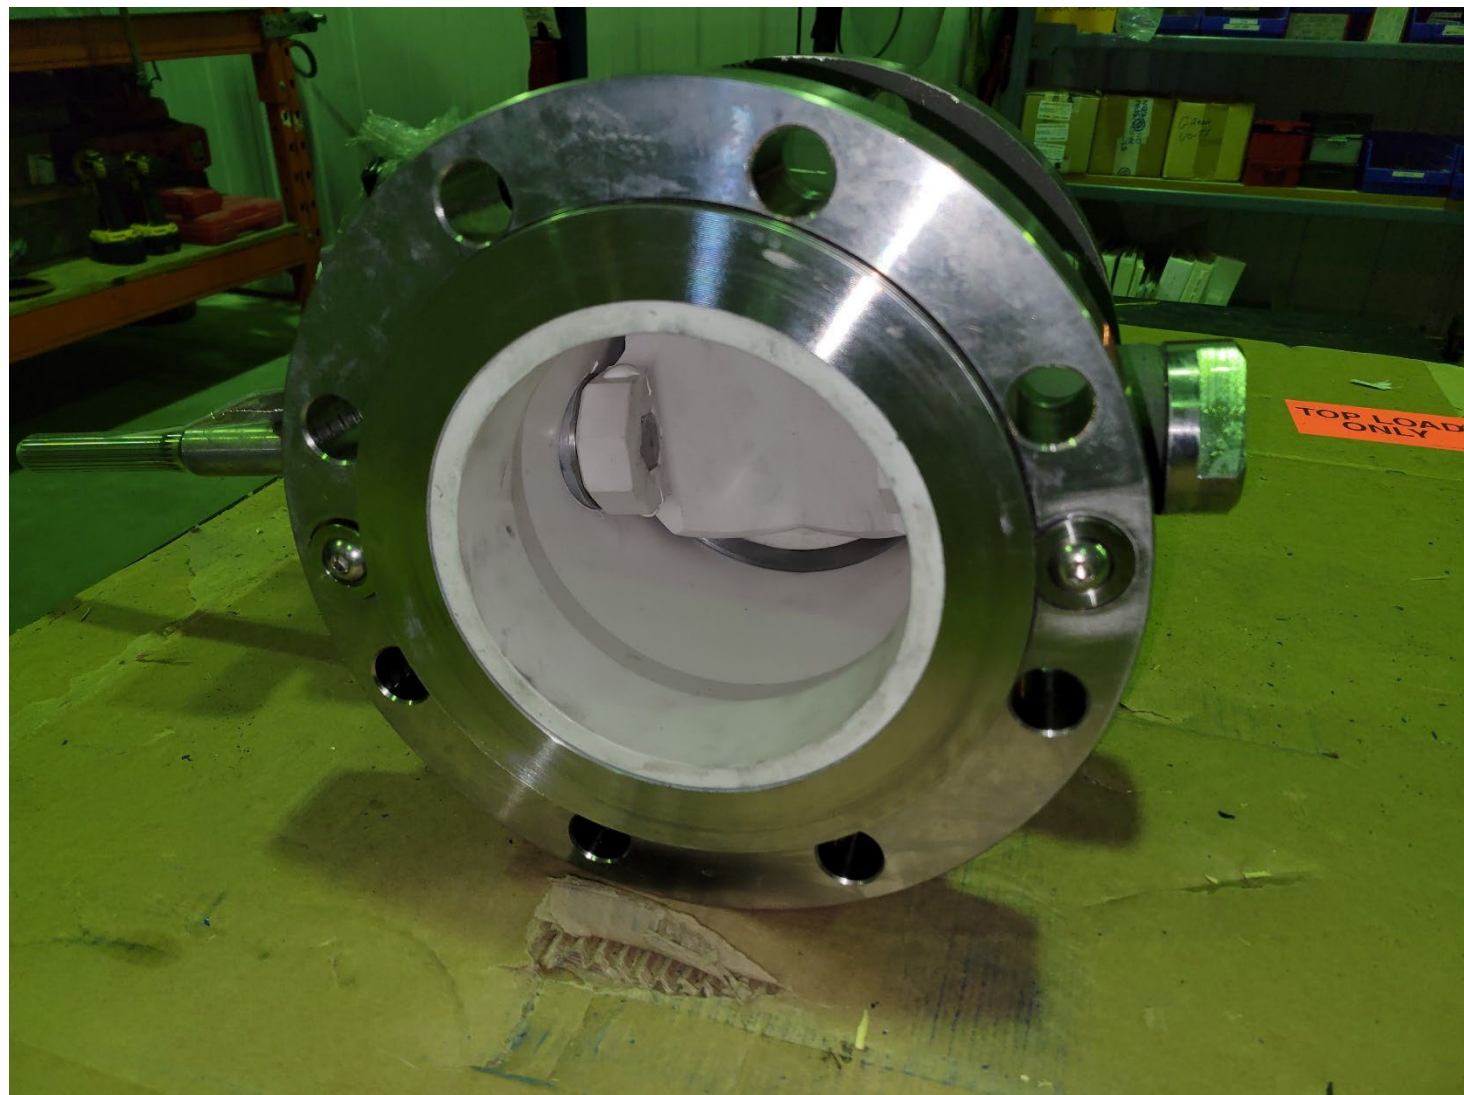
- 6" V150S, SST body, Reverse Flow
- Ceramic liner, plug, & Seat Ring
 - Alloy 6 Bearing

- Crossflow U/F - 12 months to 2.5 years
- Centrifuge Feed – 1.5 years to 4+years
- Thicker U/F –
 - SST Vee-Ball valve - 4 months. Tried both forward and reverse flow.
 - Coated - tried forward flow - 8-10 months, then tried TC reverse flow - 12 to 14months
 - Ceramic installed – going 2.5 years with very minimal wear
